Prosthetic Rehabilitation of Nose After Partial Rhinectomy in a Patient Affected with Mucormycosis: A Case Report

Clinical Report

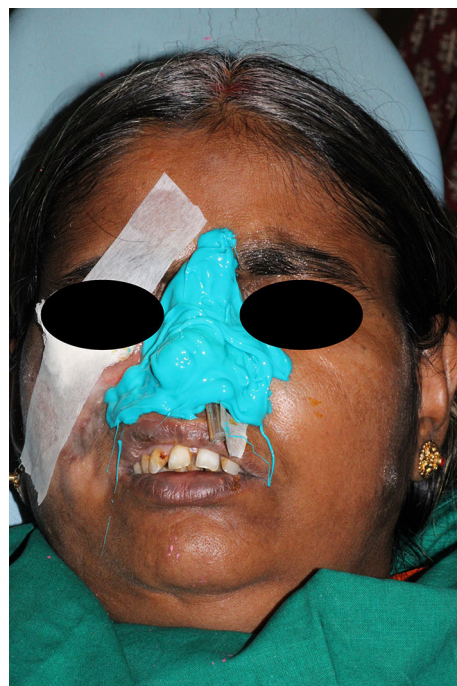
Fig. 1 Polyvinyl silicone (light body) impression keeping airway patent

The patient was made to sit on a dental chair which was reclined at a 45° angle. Petroleum jelly was then applied on the eyebrows, eyelashes and surrounding areas. A suction tip, cut to 2 inch length was placed in the left nostril to prevent the displacement of the ala and flow of the material into the nostril of the patient during impression making procedure. The deep undercuts were blocked using moist gauze. The patient was encouraged to breathe through her mouth and impression was made using a light body polyvinyl silicone material (Aquasil LV Ultra light body cartridge, Dentsply sirona) which was used to accurately record the defect site and also cover normal tissues (Fig. 1). Then the material was reinforced using Putty consistency Polyvinyl silicone material (Aquasil soft putty/regular set, Dentsply). The impression was carefully removed and then poured with type-IV gypsum (Elite Rock thixotropic, Zhermack). Deep undercuts were then blocked on the retrieved cast using modelling wax and self cure clear acrylic (DPIRR cold cure, Mumbai) was mixed and adapted to the defect site. It was allowed to set, then retrieved and trimmed to a uniform thickness of 2 mm. The acrylic baseplate was polished using a sandpaper of 120 grit size. The acrylic baseplate was placed on the cast and checked for the accuracy of fit and retention (Fig. 2). Once satisfactory, wax was moulded on the acrylic baseplate according to patient's descriptions of her preoperative appearance and the knowledge of normal anatomic contours [7]. The wax pattern was verified on the patient (Fig. 3) and flaked using Type-II plaster/ dental plaster. Dewaxing was done by immersing the flasks in boiling

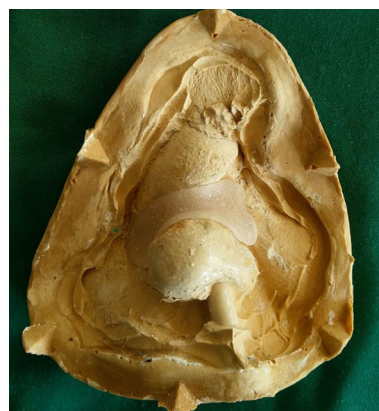
Fig. 2 Type II gypsum mould poured and fabrication of acrylic shim

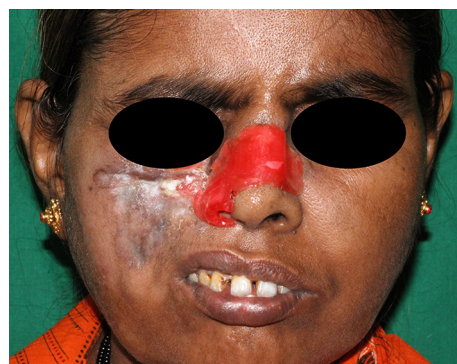
Fig. 3 Wax pattern fabrication

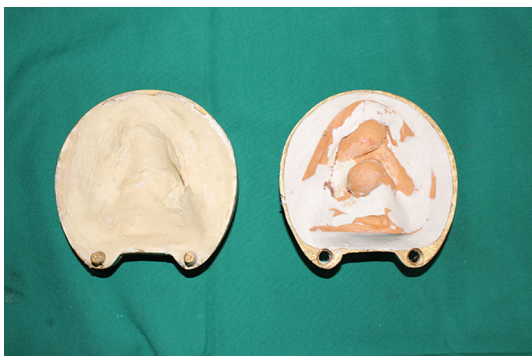
Fig. 4 Flasking of the pattern with two pour technique

water for 4 min (Fig. 4). The flasks were opened and wax was eliminated using hot water. A primer was then evenly applied on the acrylic baseplate so that silicone could bind to the acrylic material (Universal tray adhesive, Zhermack). Room Temperature Vulcanising Silicone (Silicone for prosthesis, MP Sai enterprises, Thane) was mixed with intrinsic stains and colour matching was done. Different shades of silicone was packed according to the shade of the natural skin adjacent to the prosthesis. The flask was clamped and kept for 24 h so that the material sets sufficiently. It was retrieved the next day, the excess was trimmed and prosthesis was verified on the patient for retention (Fig. 5). Extrinsic staining was done to closely mimic the adjacent pigmentation on the skin. The prosthesis was delivered to the patient and home care instructions were given (Fig. 6).

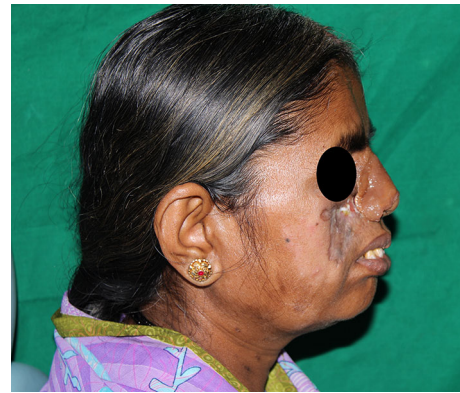
Fig. 5 Tryin of the fabricated silicone prosthesis

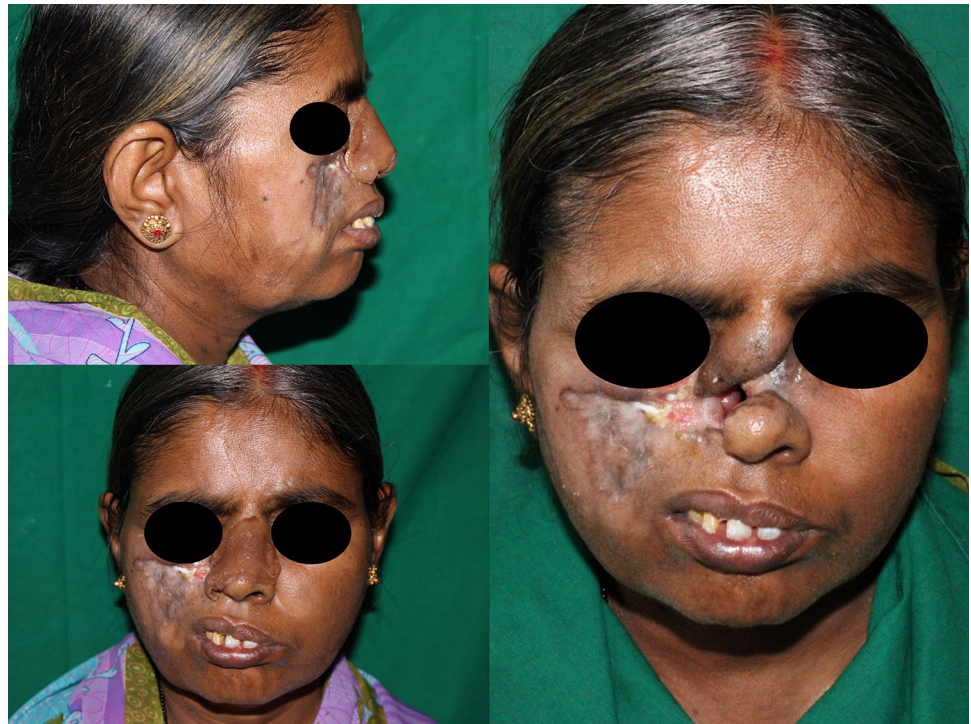
Fig. 6 Insertion after extrinsic staining
